Norfolk International Airport Tree Report

Phase I

Prepared by Signature Landscapes

February 18, 2021

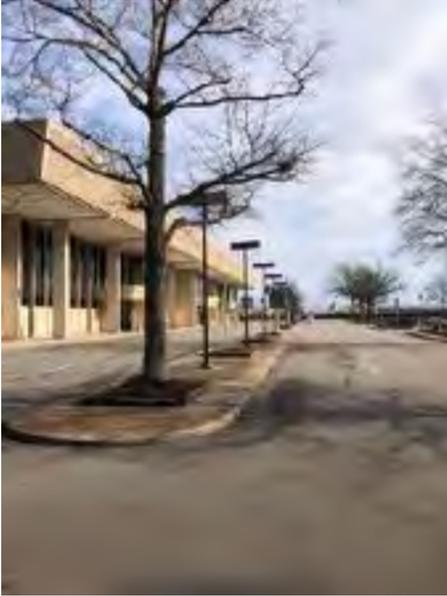
This is an unsustainable growing environment for these trees. Not only do they lack sufficient volume but all the attending issues associated with this condition are present. This would include water, oxygen, nutrients, microorganisms, temperature buffers, that would be limited by the lack of soil required for a tree of this size. Additionally, as the tree reaches the threshold of available soil and is unable to continue its normal development its defense system is compromised and disease pathogens and pests can hasten its decline.

This photo is the roadway and median on the Southside of the Departure Terminal.

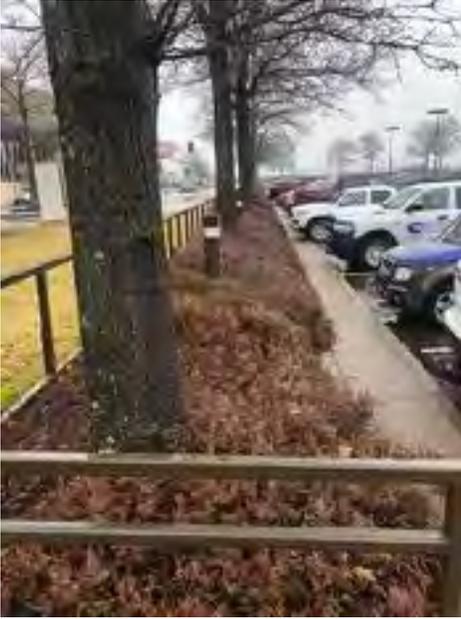
Planting Pit L - Exit Rd, Parking

These trees are located at the entrance to the Departure Terminal along the roadway and adjacent parking lots including a median next to the terminal. All of these trees are Willow Oaks, *Quercus phellos*. At full maturity they can reach a height of 60 feet, have a canopy spread of 30-40 feet and DSH can exceed (24) inches. Of the (26) trees only about seven have the soil volume needed to reach some measure of maturity. Many of these trees exhibit various stages of stress/decline directly associated with limited soil volume and rooting space. This would include dieback in the crown, active disease pathogens, loss of vigor, stunted growth, and incomplete sealing of pruning cuts. Included in the report is a section titled "Special Conditions" where this issue is described in detail and its impact on a tree's longevity. There have already been several trees removed in this area and others have been pruned or the crown has been reduced because of dieback. The median strip has five empty pits where the trees have been removed.

Recommendations: Willow Oaks were not a viable selection for this site because of the soil volume required for them to reach maturity and remain healthy. With the exception of the four trees located in the curve approaching the terminal and maybe three more that may have sufficient soil, the others should be removed.

Currently, we recommend that Trees #'s 14, 15, 23-26 should be removed immediately. All of them are in decline and have dead parts. In an abbreviated time span the others will continue to decline and require parts to be removed for safety concerns. This is a highly trafficked zone with pedestrians and vehicles and their safety is a high priority. Once these trees begin the process of decline they will continue to display dieback and shed limbs/branches. The process may take a few years but the end result will be removal. It seems prudent to remove the entire tree instead of a piecemeal approach that is more expensive in the long term, necessitates an almost constant inspection protocol, and could still cause injury/damage because of falling limbs/branches. Additionally, the narrow strip between the roadway and parking lot restricts root plate development which makes these trees prone to failure in wind events. If removal is not possible at this time all the remaining trees should be crown cleaned (removal of all dead tissue two inches or larger), to minimize potential impact.

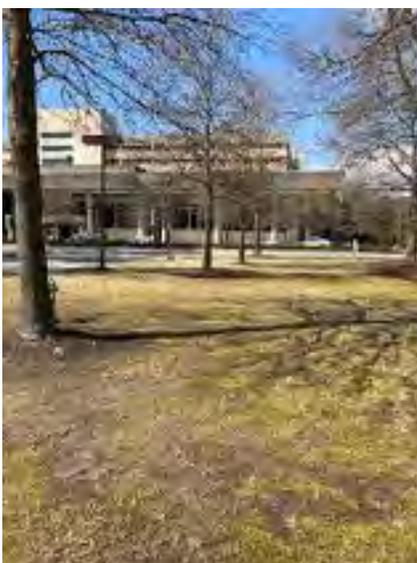
North Terminal Soil Vol.

These trees are located on the north side of the terminal and bounded by the road on one side and a parking lot on the opposite side. It also includes a median with three Willow Oaks. The majority of the trees have significantly restricted soil volumes. Further exacerbating problems, many are growing on slopes which are impacted by runoff. Several trees have been removed from the median, evidence of crown reduction and limb removal from dieback was observed. Trees #52-59 and #65-70 may have sufficient soil volume at this time to sustain them. Several trees have dead tissue and dieback in their tips indicative of poor vigor. Trees #62, 77, 78, have coalescing wounds that weaken the support structure. On Tree #56 we noted the fungi, Candelaria, on the trunk...it is a lichen.

Recommendations: All of these trees are Willow Oaks and should not have been installed in these planting pits and along the roadway and parking lots. The available soil volume is extremely under proportioned for a mature Willow Oak. Per our previous recommendation they should be removed and replaced with an appropriate species for the planting sites. Tree #70 should be removed immediately. It has shelf conks approximately 12 feet above grade indicative of an active decay organism. It has a wound opening 2.5 feet long that exhibits poor sealing indicating reduced vigor and dieback in the crown. Numbers 78 and 79 have dieback in their tops and should be candidates for removal. The trees with coalescing wounds should also be considered for removal. All the remaining trees should be crown cleaned for safety.

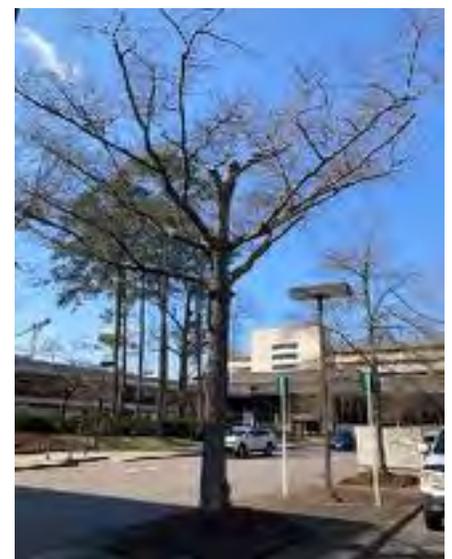
Median, Topped Tree

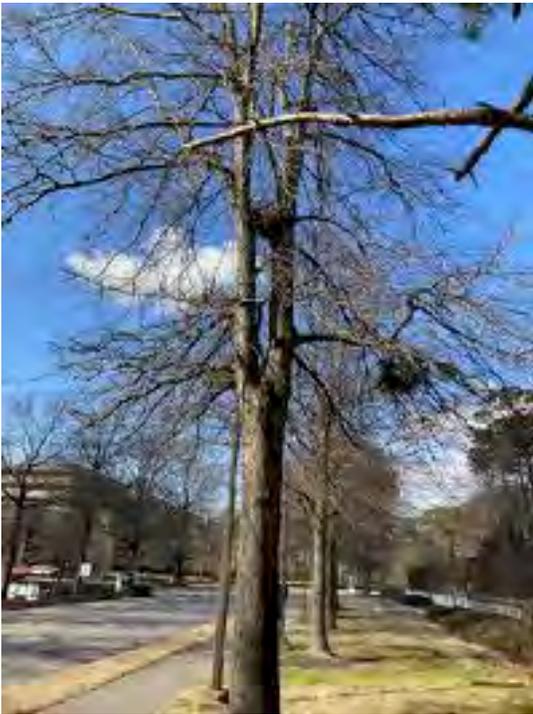
Codominant Stem #91

Recommendations: All the trees should be crown cleaned and some raised to avoid contacting vehicles. Mower heights should be adjusted to prevent future damage to exposed roots. Trees #97-98 should have an aerial inspection on some lower limbs and trunk.

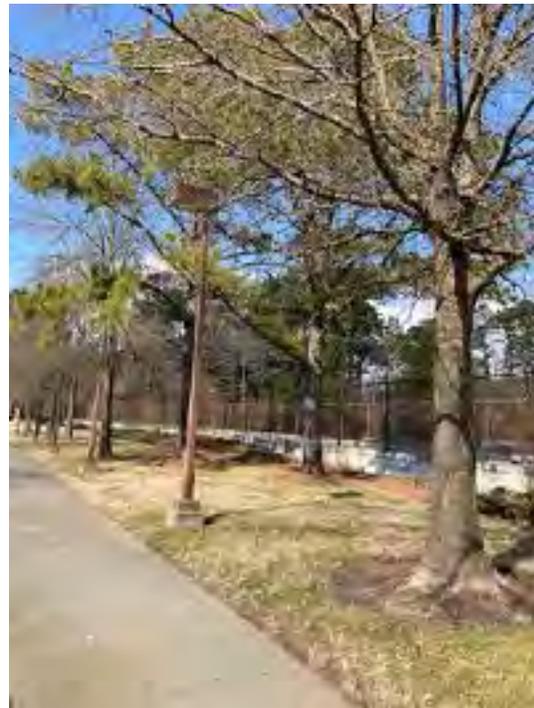
Sufficient Soil Volume

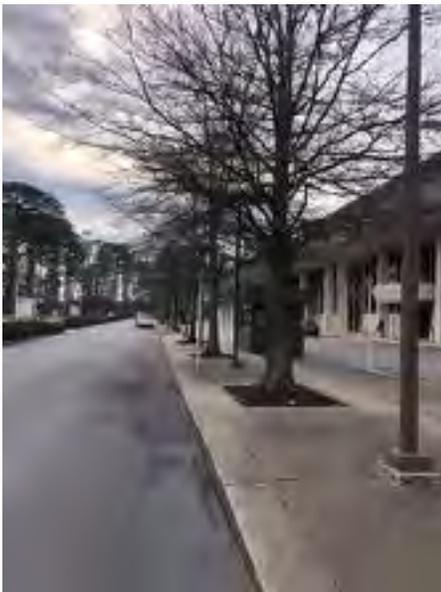
Median Baggage Terminal

In front of the baggage terminal: There are (18) Willow Oaks located in these 6x9 feet planting pits. Our best estimate is they are approximately two feet deep and provide roughly 108 cubic feet of soil. This is extremely inadequate for healthy growth and longevity.

Recommendations: These planting pits are not sufficient to sustain the health and potential growth of the Oaks. Please refer to the next section on “Special Conditions “ for a more comprehensive evaluation of this issue.

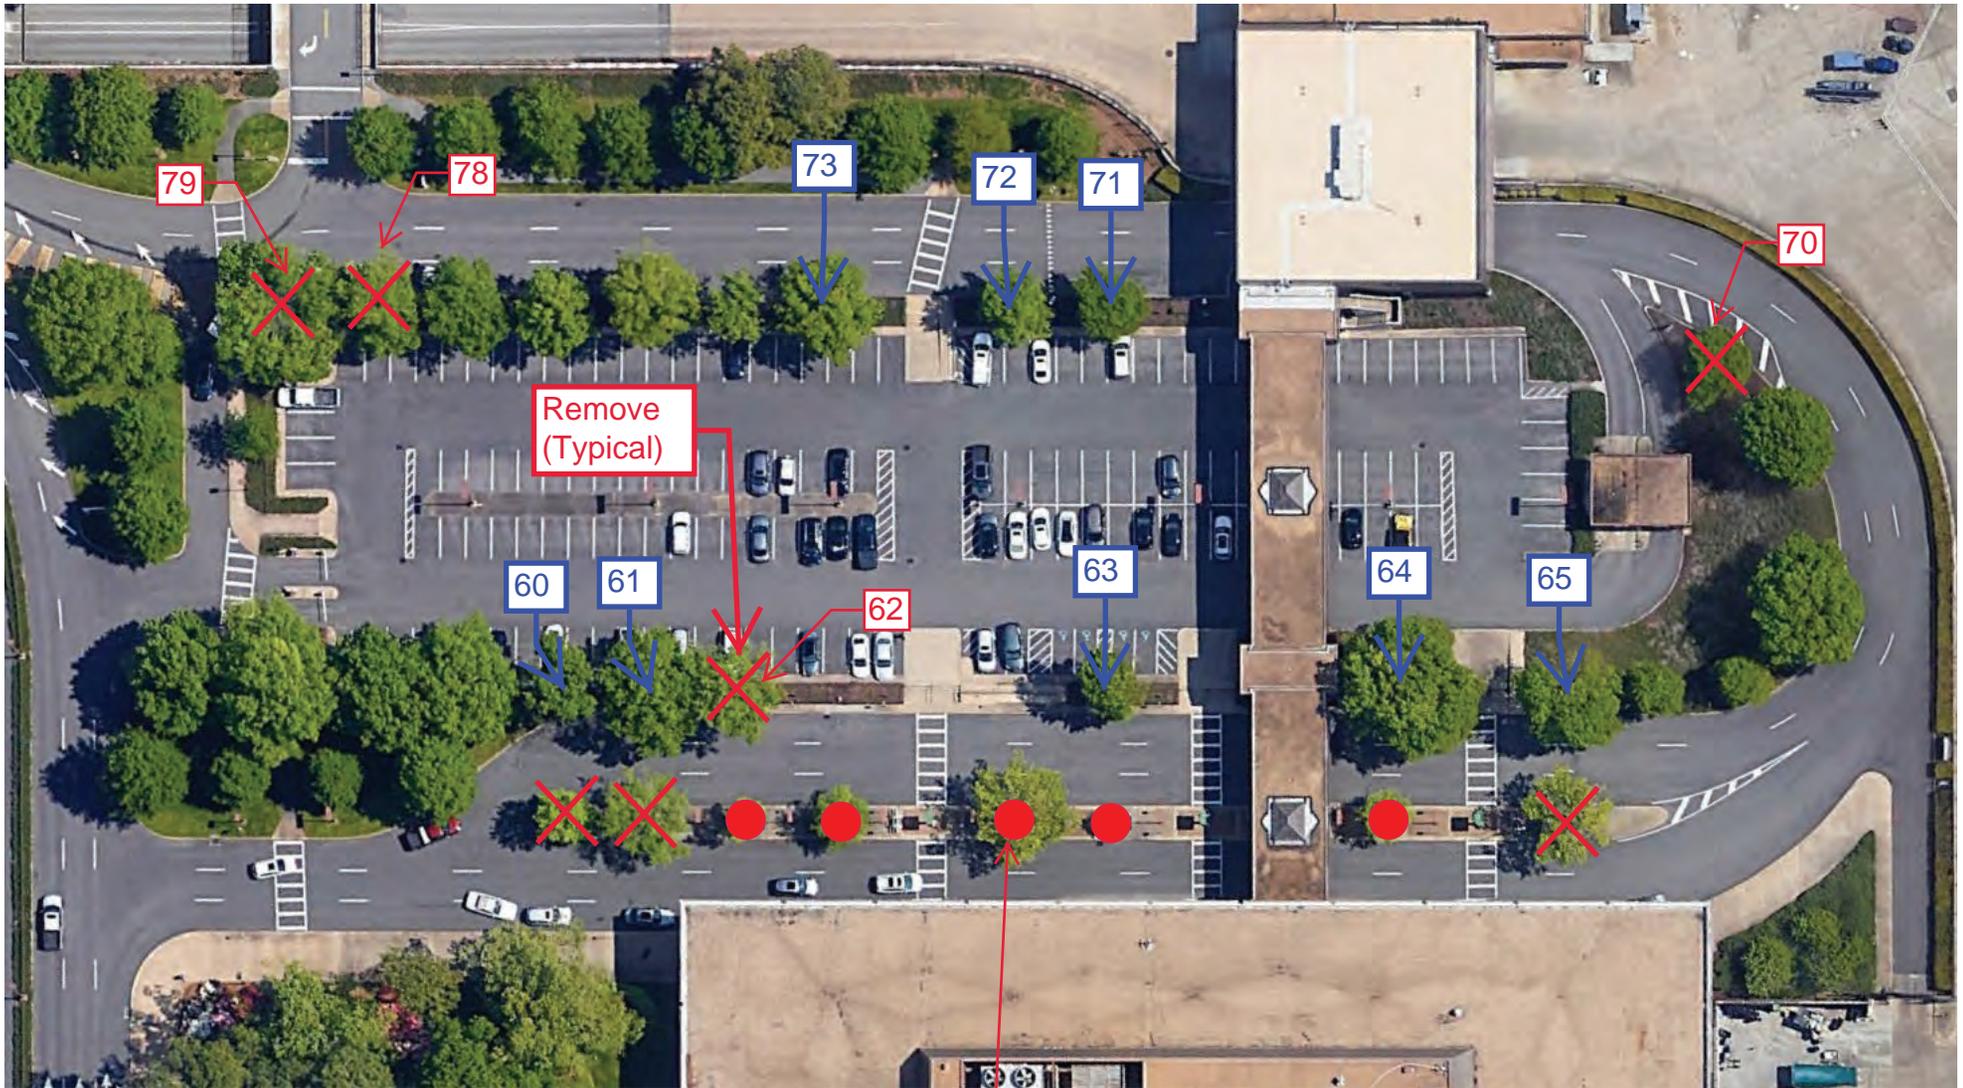
Phase 1 - Departure North

Trees previously removed due to very poor condition (Typical)

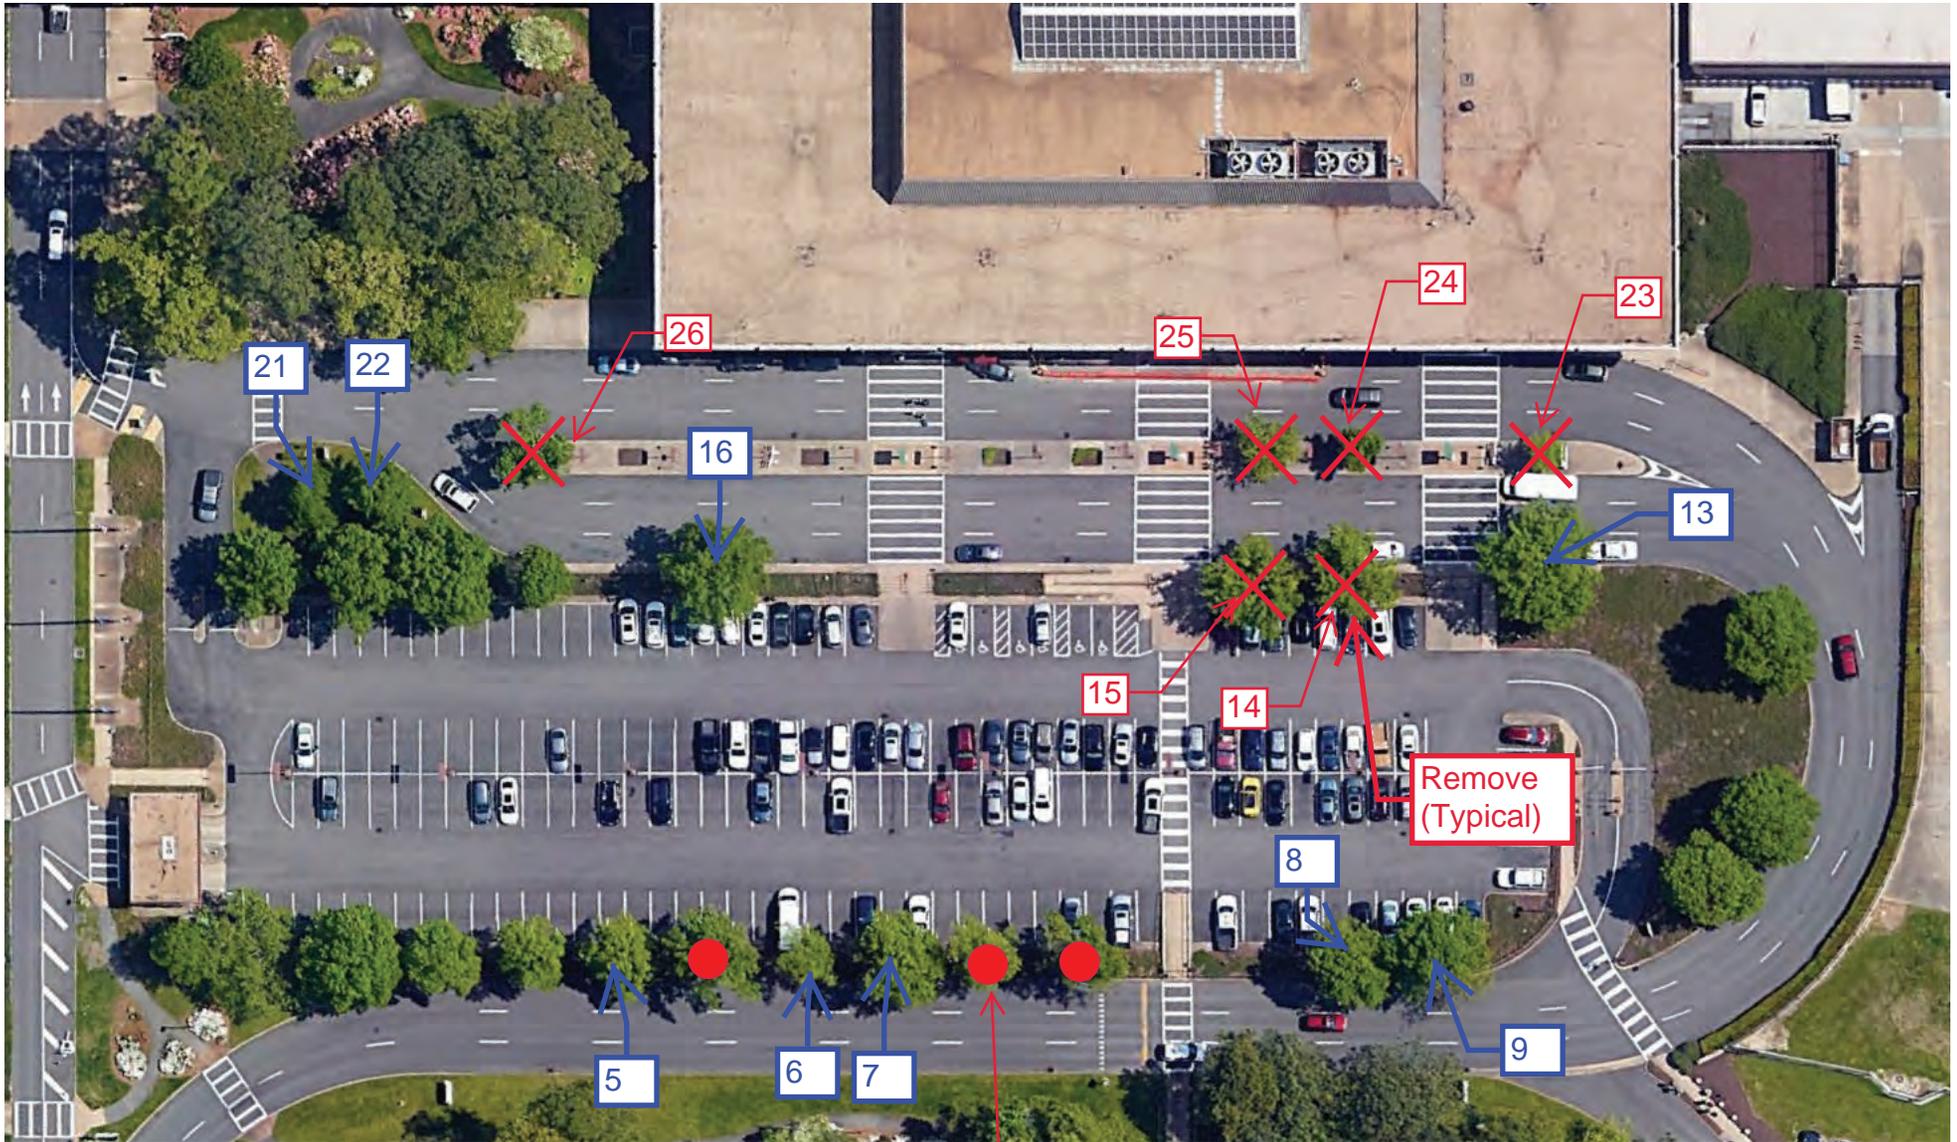
Phase 1 - Departure South

Trees previously removed due to very poor condition (Typical)

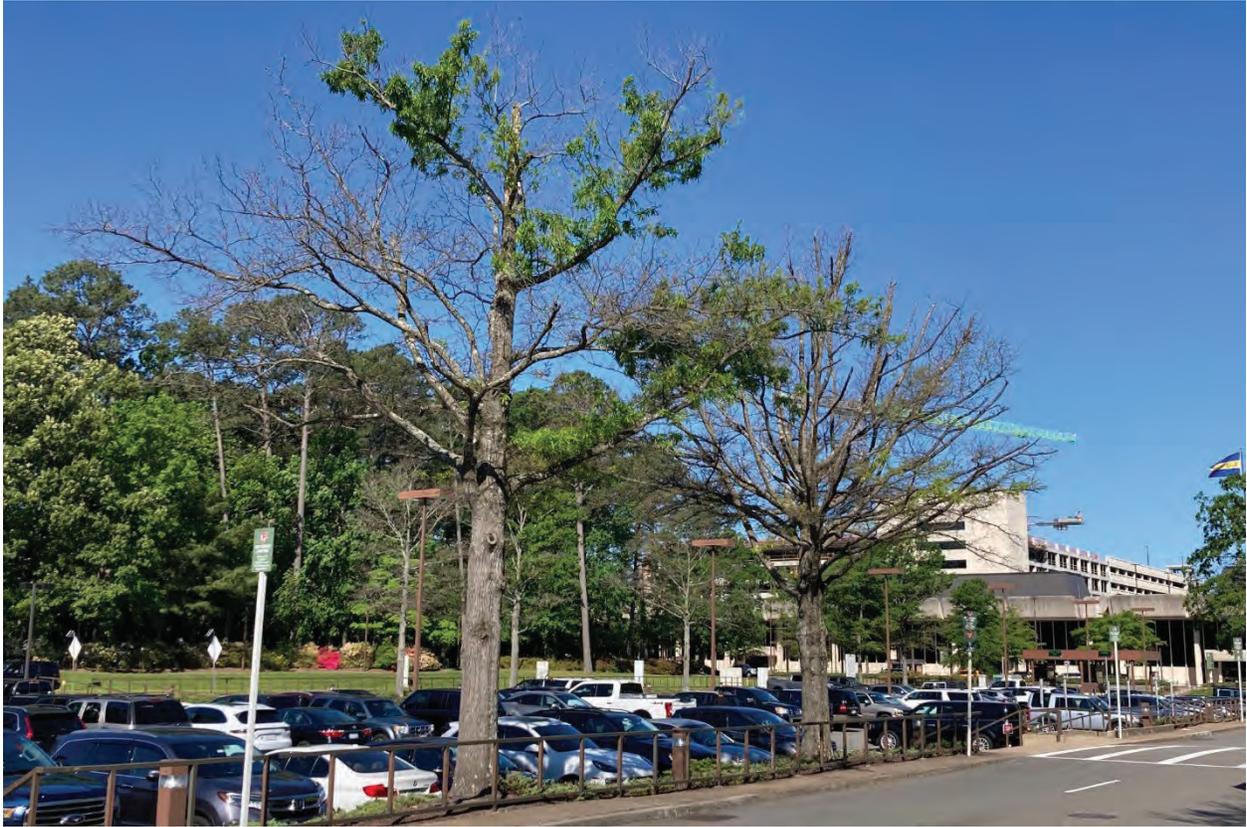
Typical Short Term Lot Trees to be Removed

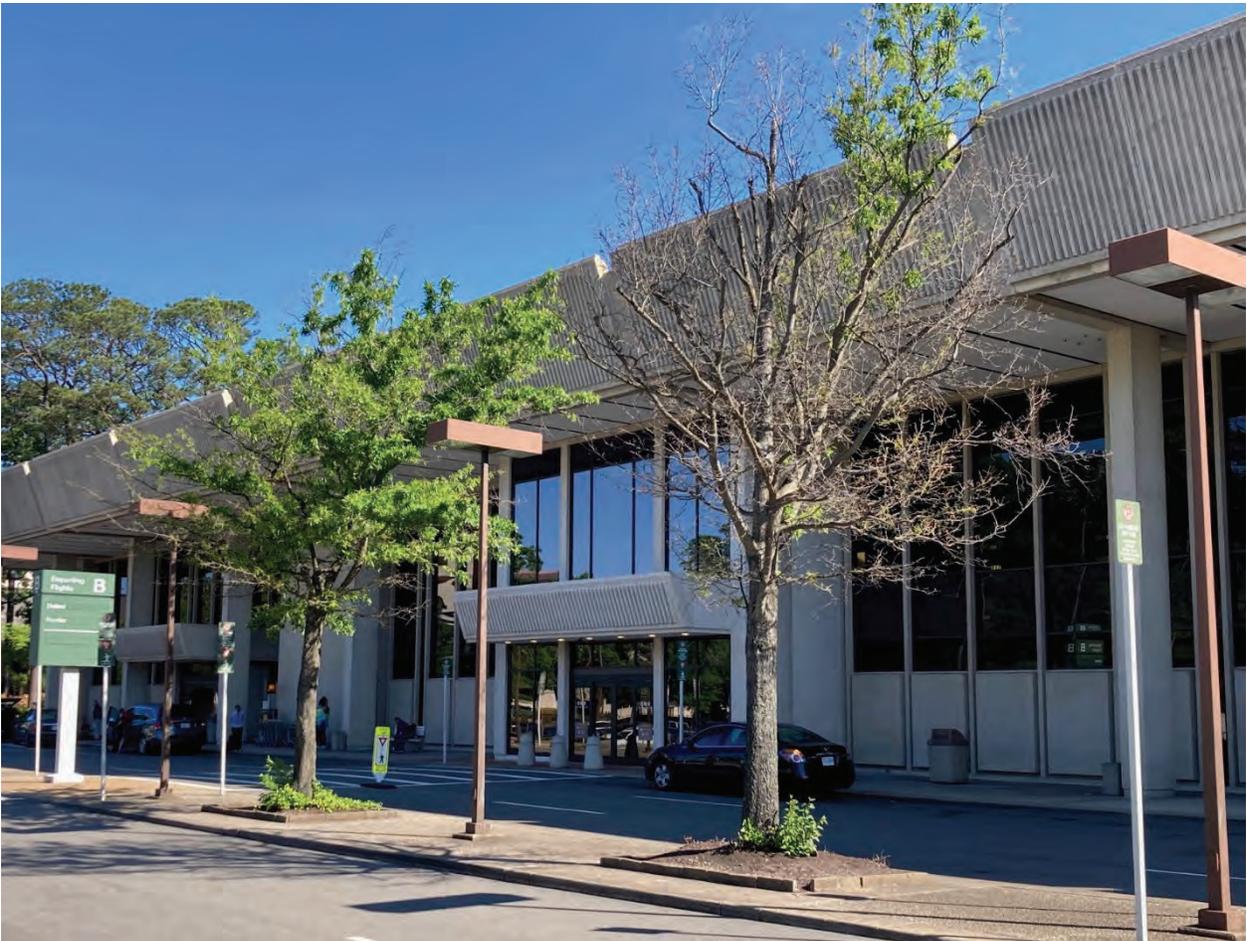
Typical Departures Median Trees to be Removed
