Norfolk International Airport Tree Report

Phase I

Prepared by Signature Landscapes

February 18, 2021

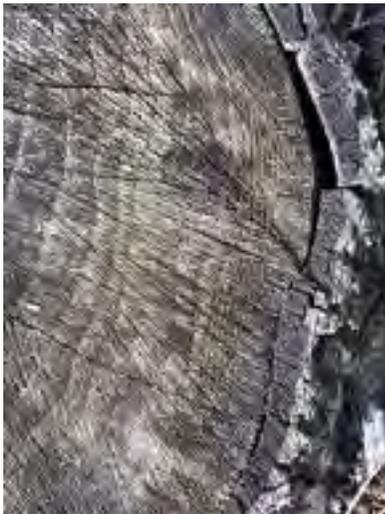
This has led to the current condition of the trees. Some of the trees have already been removed, some need to be removed, others are in various stages of decline, some are beginning to show early stages

of having exploited the limited soil resource, and a few that may have a sufficient amount of soil still available (these would be the ones located in the curves of the roadway where more soil is available). In time the trees located in the limited soil areas will decline and die. In the picture to the left, in the early years the growth rings are wide, as the soil volume is exploited by the roots the growth rings get smaller until the tree dies.

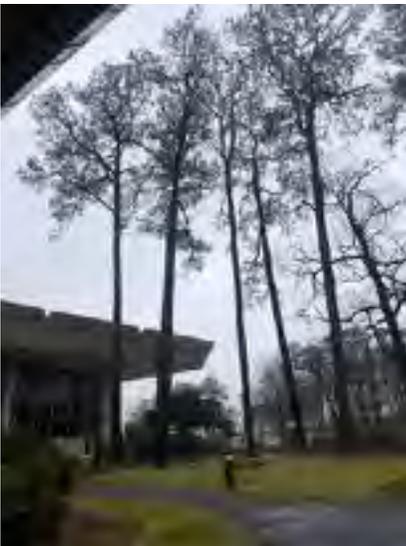
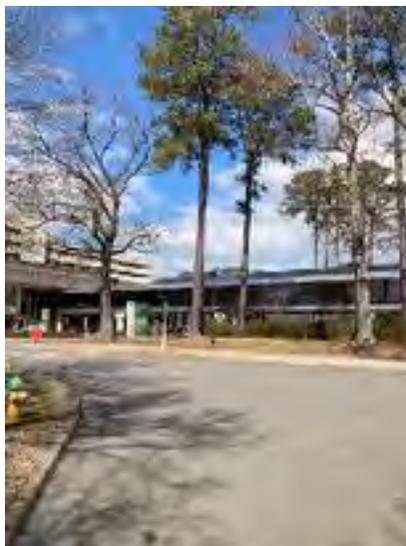
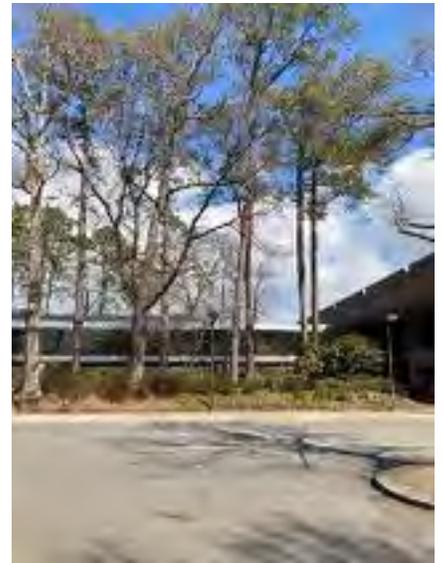
TREES 27 - 39

Specifically #31, a Loblolly Pine with a DSH of 21.4 inches and a height of approximately 80 feet, has its canopy on one side and leans toward the roadway and unloading area for passengers. Pines #27-28 have co-dominant parts. Typically, pines in wind events tend to fail 10-20 feet above grade. Several of these pines, if they failed, could impact the Skywalk, terminal, or the roadway. Trees #34, 35, and 37 are large Oaks. Their DSH all exceed 30 inches, heights above 55 feet and canopy spreads of 47 to 62 feet. All three are adjacent to the roadway/sidewalks and their canopies extend over them. General health and physical condition are within normal ranges for their size. All of them have had some prior pruning and have lost some limbs/branches probably due to wind events.

Tree #37 has a hanger over the roadway which needs to be removed.

Tree #35 has a cavity (1"x 8") approximately 15 feet above grade...unable to determine the extent of cavity because this is a visual evaluation only. No climbing was involved to assess above ground defects. These trees have been able to reach maturity, in part, due to sufficient soil volume.

Recommendations: Due to the walkways and curbside departures the trees need to be crown cleaned (deadwood larger than two inches removed) and some limb/branch structures on the Oaks that overhang the roadway and sidewalk could be reduced to lessen the extended weight load. An aerial inspection should be done by the Arborist doing the crown clean/ limb and branch reductions for any defects not detected by the visual exam from the ground.

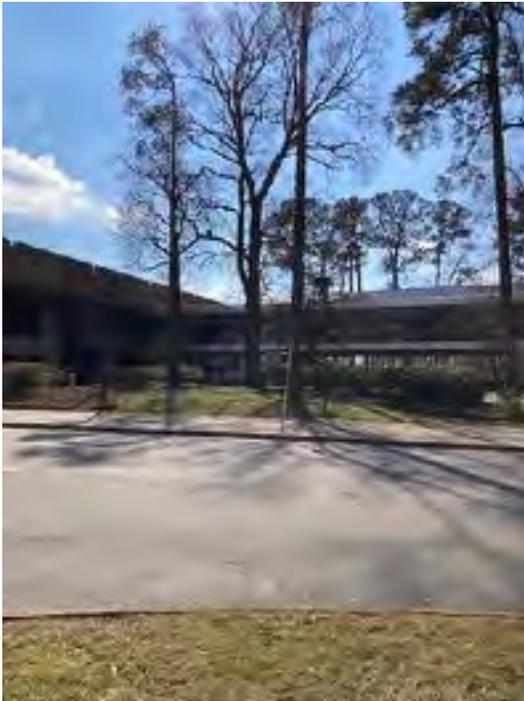
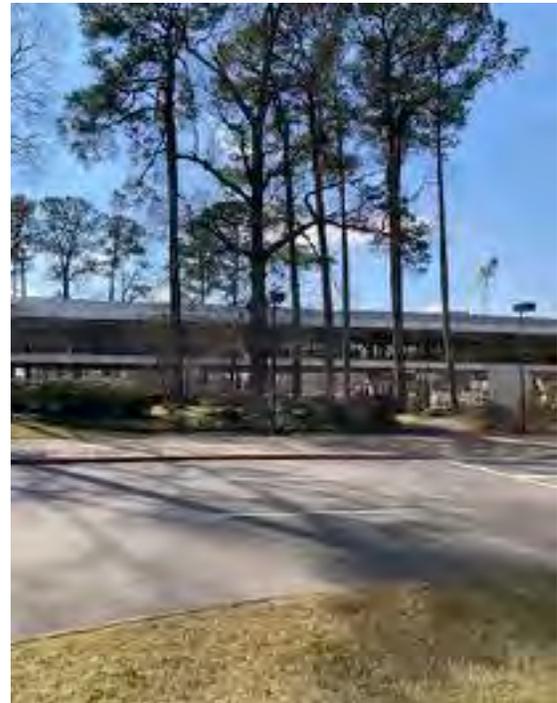
TREES 40 - 51

These trees are located on the north side of the Skywalk and adjacent to the terminal. It is bordered by the roadway and has sidewalks and asphalt walkways for pedestrians. Most of the trees are mature Loblolly Pines that range from 19-28 inches DSH and have heights of approximately 80 feet. Did not detect any significant defects but because of their heights and some unbalanced crowns they could impact the Skywalk if they failed in a wind event. Tree #51, a Loblolly Pine, leans toward the terminal because of the crown of a large Oak on the opposite side. We noted some wounds on surface roots likely caused by mower damage. Trees #46, 48, and 50 are mature Oaks with DSH from 29 inches to 46 inches and heights of 70-85 and significant canopy spreads. Tree #46, a Black Oak, was crown cleaned and had some large limbs/branches removed in December 2020 that were dead or had dieback. The only other tree is a Bitternut Hickory with a DSH of 14 inches and a height of approximately 40-45 feet. Again, these trees have been able to obtain maturity, in part, due to sufficient soil volume.

Recommendations: All the trees should be crown cleaned to remove deadwood as noted previously. Any type of vine should be cut at the base and removed from the trunk to at least 10 feet. English Ivy can conceal defects and should be removed from any tree located near a building, roadway, and pedestrian access. An aerial inspection should be done by the Arborist doing the crown cleans for any defects not detected by a ground observation. Special Note: A large Oak was removed from this area in December 2020 due to significant dead tissue and progressive dieback. The tree was in decline and photos at the end of the report will show the extent of decay.
